# espc::home report

2/2 Hermitage Park Lea  
Edinburgh  
EH6 8DY  
01/10/2025

# Single Survey

## Survey Report on:

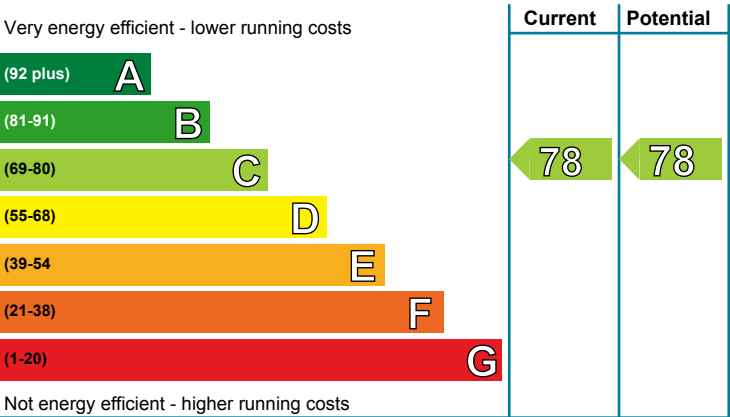
### Energy Efficiency Rating

This graph shows the current efficiency of your home, taking into account both energy efficiency and fuel costs. The higher this rating, the lower your fuel bills are likely to be.

Your current rating is **band C (78)**. The average rating for EPCs in Scotland is **band D (61)**.

The potential rating shows the effect of undertaking all of the improvement measures listed within your recommendations report.

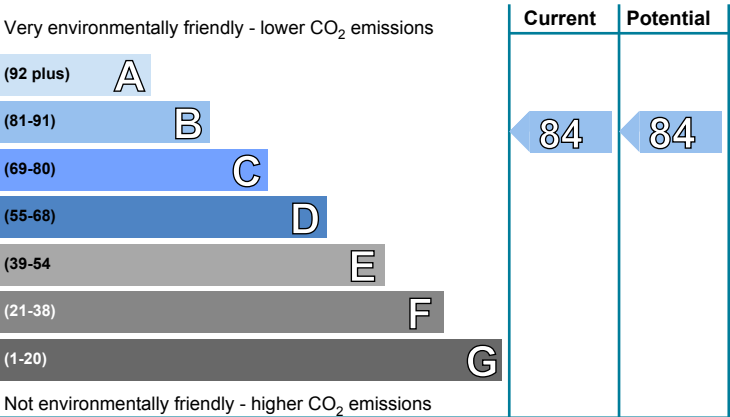
### Environmental Impact (CO<sub>2</sub>) Rating

This graph shows the effect of your home on the environment in terms of carbon dioxide (CO<sub>2</sub>) emissions. The higher the rating, the less impact it has on the environment.
